INVESTIGATION: EA91-010

SUBJECT : GEAR SHIFT LEVER FAILURE
 PROMPTED BY : DP90-014

ENGINEERING ANALYSIS CLOSING REPORT

SUBJECT: ALLEGED MALFUNCTION OF AUTOMATIC TRANSMISSION
PARK LOCK SYSTEM IN 1981-1990 CHRYSLER MOTORS
CORPORATION VEHICLES

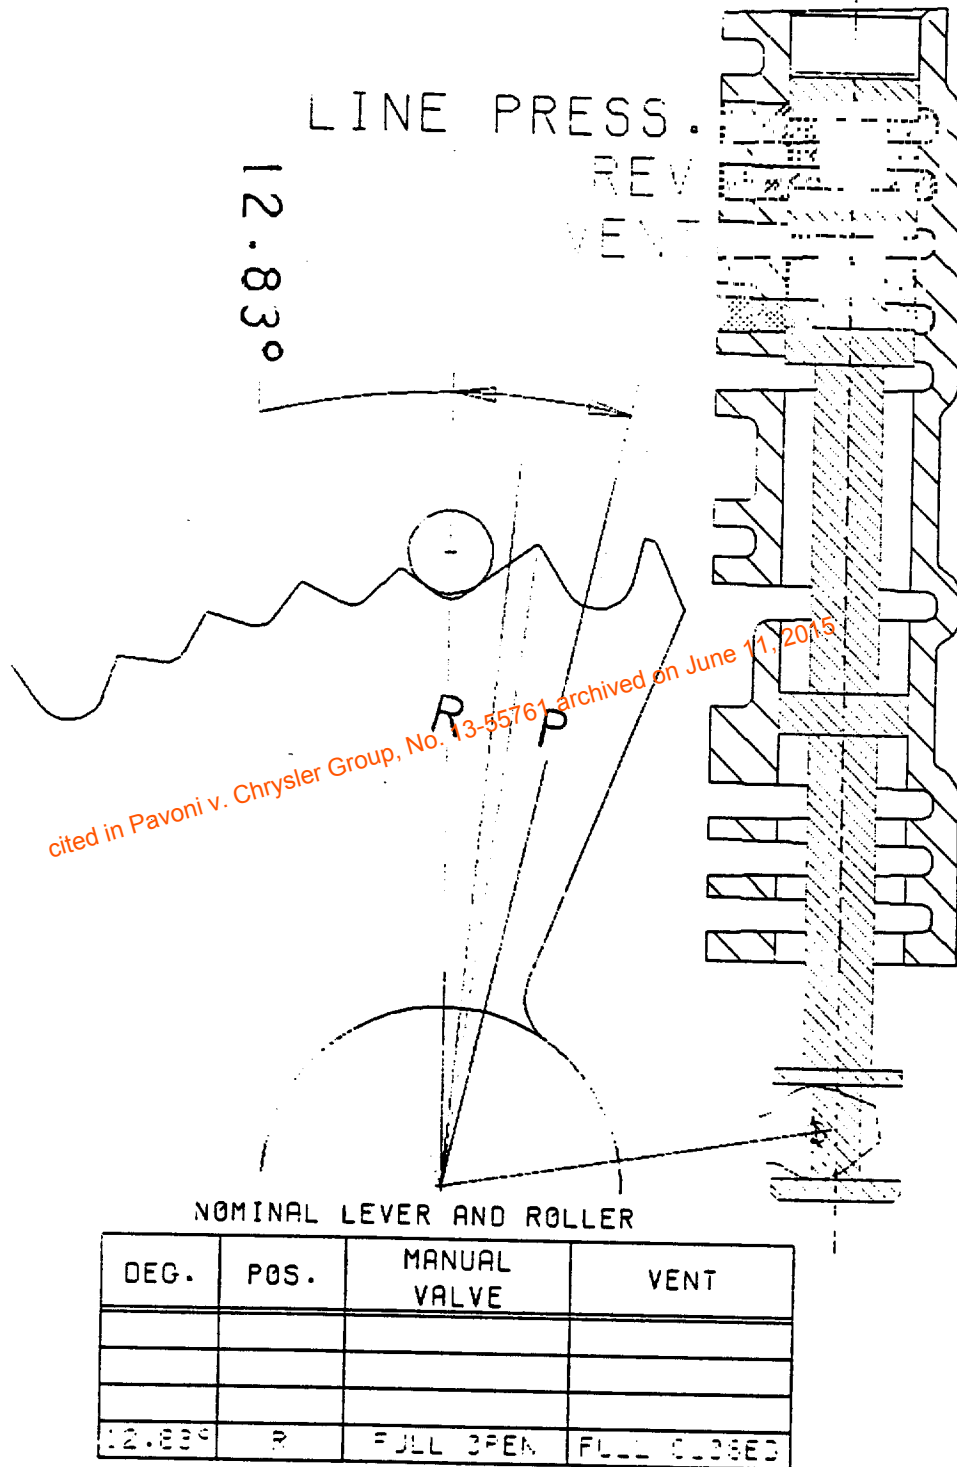
From Figure 6, it is seen that the angular displacement of the detent roller from the bottom of the Reverse position to the bottom of the Park detent is 12.83 degrees. With the detent roller in the reverse gate, the manual valve is actuated to the full open position in the reverse gear circuit.

Figure 6. Angular displacement between reverse and park in rooster comb. Detent roller at reverse gear, manual valve fully open at R, vent fully closed.

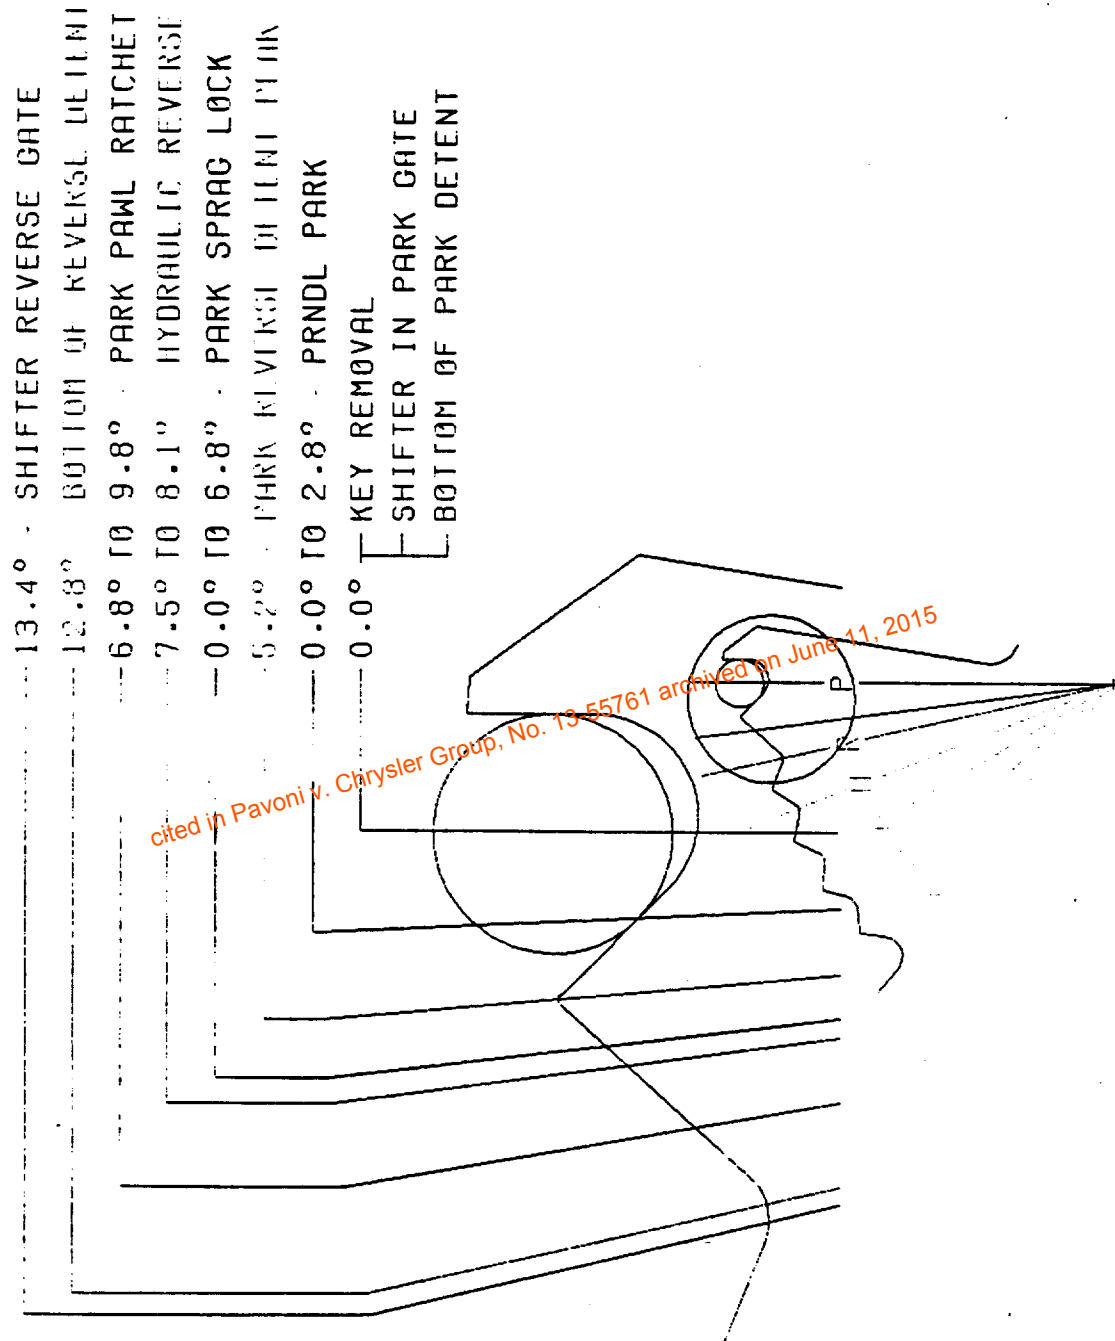
Figure 7 shows further detail of these relationships. This depicts the full angular displacement between Reverse on the shift lever gate and Park on the rooster comb of 13.4 degrees. When the shift lever is moved from Reverse-to-Park, hydraulic reverse is lost at 8.1 degrees before the shifter seats in the Park gate, meaning that the manual valve closes the Reverse fluid circuit in the transmission. At 6.8 degrees before seating of the roller in the Park detent, the park sprag locks in the Park position. This occurs 1.6 degrees before the Reverse-to Park detent peak is reached, or 5.2 degrees before full seating of the roller in the Park detent. At 2.8 degrees before full seating of the detent roller in the Park detent, the PRNDL indicator inside the passenger compartment will indicate that the Park position has been selected. At zero degrees, the shift lever is fully seated in the park gate inside the steering column, the detent roller is seated at the bottom of the Park detent on the rooster comb, and the ignition key can be removed from the switch.

Several facts are disclosed in this information. First, the angular displacement between Reverse and the Reverse-to-Park detent peak is 7.6 degrees, or about 0.39 linear inches on the rooster comb (the difference between the bottom of the reverse detent at 12.8 degrees and the Park-Reverse detent peak at 5.7 degrees, is 7.6 degrees-See Figure 7). Tests indicate that minimal shift lever force is required to move the detent roller this distance. Because the spring loaded detent roller maintains line contact with the rooster comb, once it has passed the detent peak, it will tend to fall into the full Park position. On the Reverse side of the peak, it will tend to fall back toward Reverse, but this will occur immediately unless the vehicle is positioned so that its static rolling resistance prevents the wheels from rolling in the reverse direction.

Figure 7. Reverse to Park shift events
corresponding to angular position
of detent roller in rooster comb.
